# Friends of Queens Wood

## Report of Impact of Rain Event of 12 July 2021 on Queens Wood

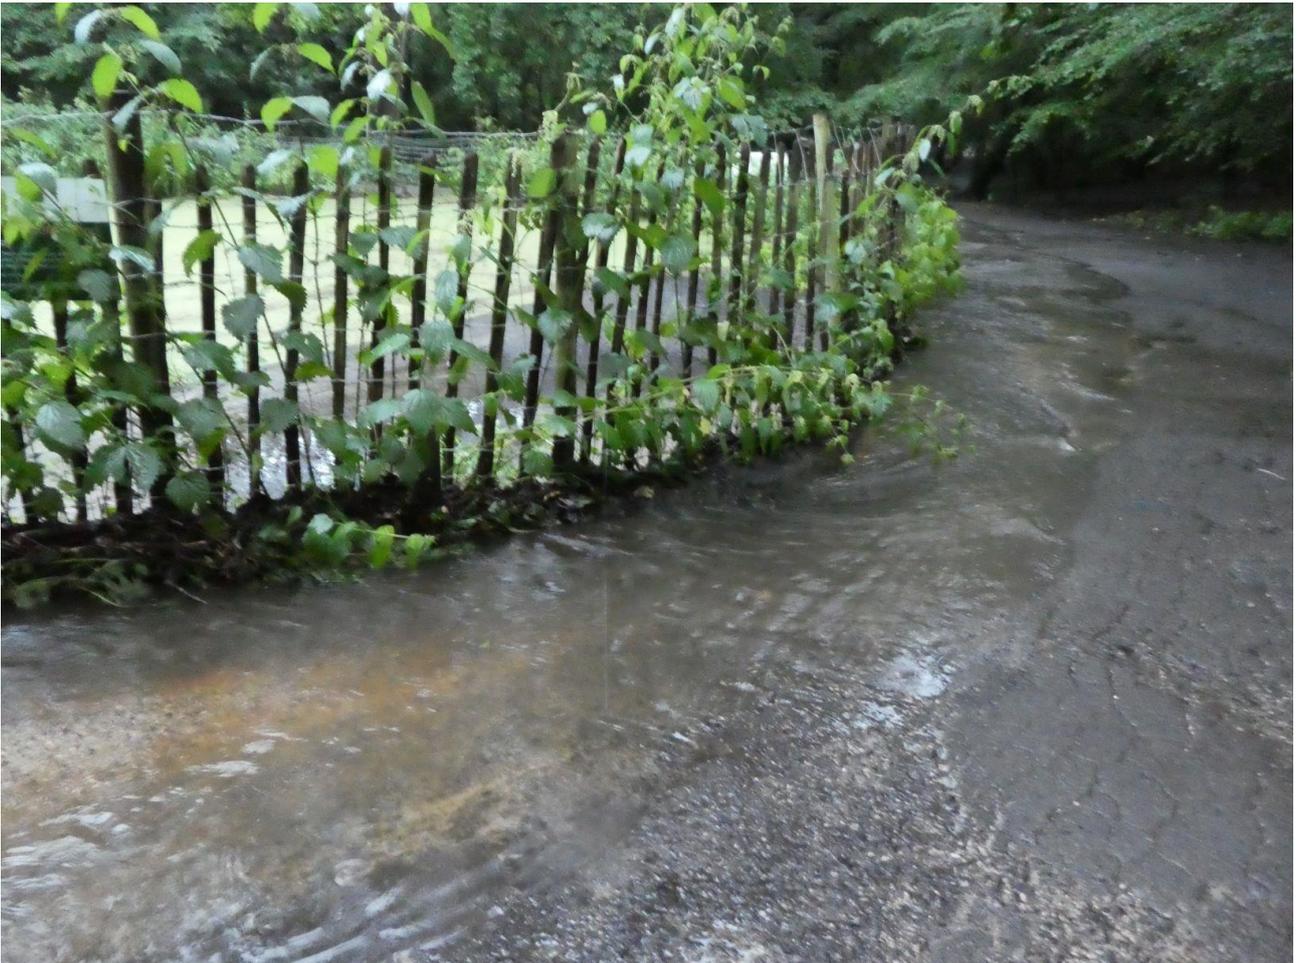
The overflow pipe to the Frogpool appeared to be blocked and the water overflowed over the path to the east of the pond.

1. 8 pm. At the Frogpool the water flowed onto the path. The earlier wide flood area is apparent.

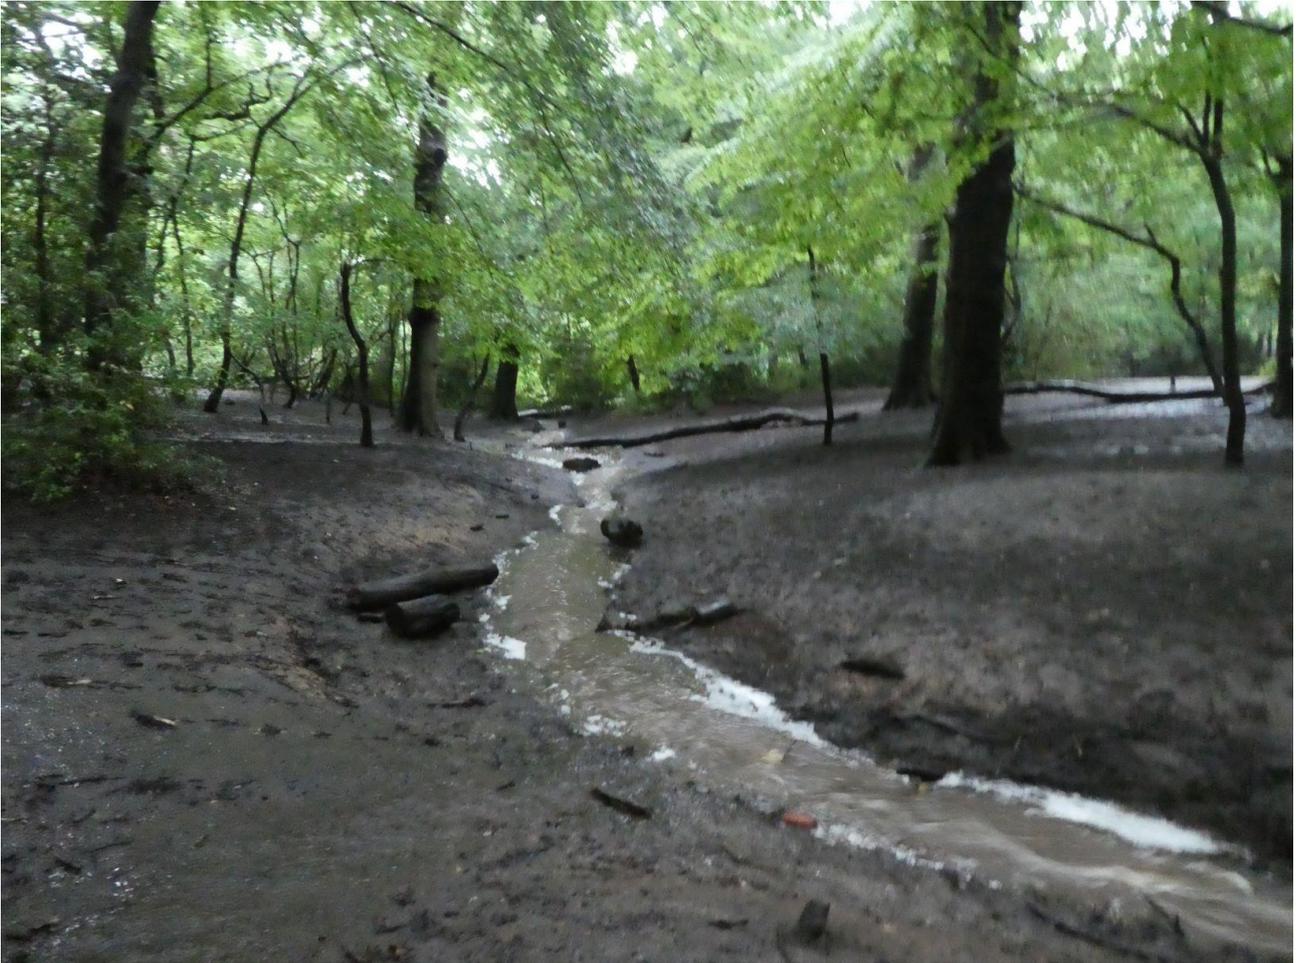
The stream between the Frogpool and the 'Dog Pond' and a wide area to either side was scoured clean of silt and soil exposing the bedrock clay. There was a visible 'tide mark' indicating the depth and width of the storm water runoff, and some of the dead hedge timbers nearby were swept away.

2. 8 pm. Between the Frogpool and the Dogpool the stream was flowing. The widespread flooding and erosion are apparent.

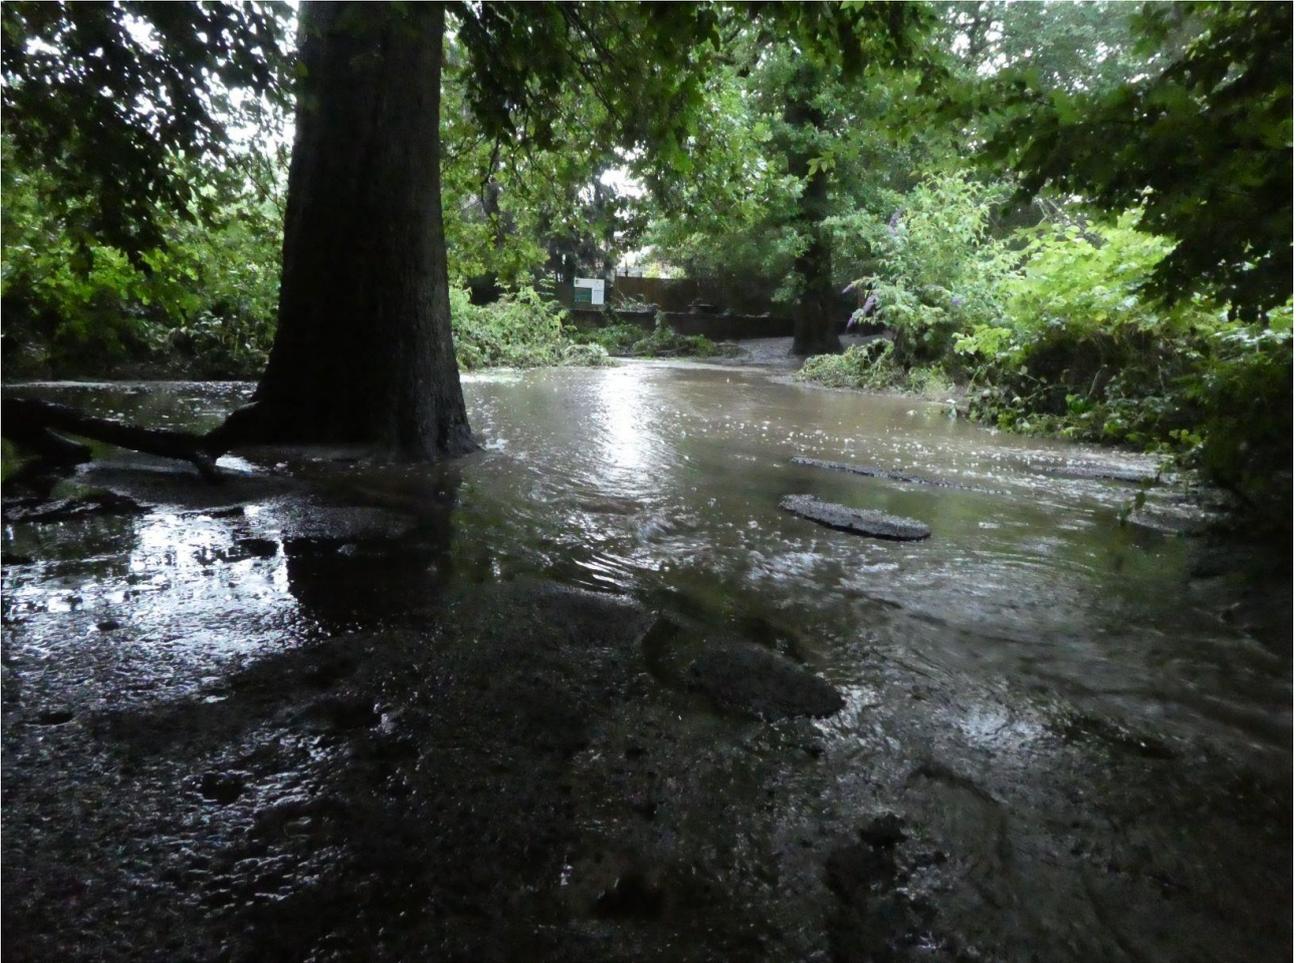
From here to the Wood Vale entrance the engorged stream ran through the undergrowth in the coppiced area. On reaching the flood wall it was initially fed into the grille and into the sewer. Before long this became inadequate and the water began to be retained by the wall. The level of retention increased and a large pond was formed. Eyewitnesses have confirmed the area filled completely before overtopping the wall and flowing round the end wall. There is no sign of any damage or possible failure of the wall. The flood water then left the wood towards Wood Vale.

3. 8 pm. Flooding approaching the Wood Vale entrance. The wall is visible in the distance below the notice board. When the wall was overtopped earlier, the water level in the entire area would have been more than a metre deeper. This is shown by the effects on the adjacent vegetation.

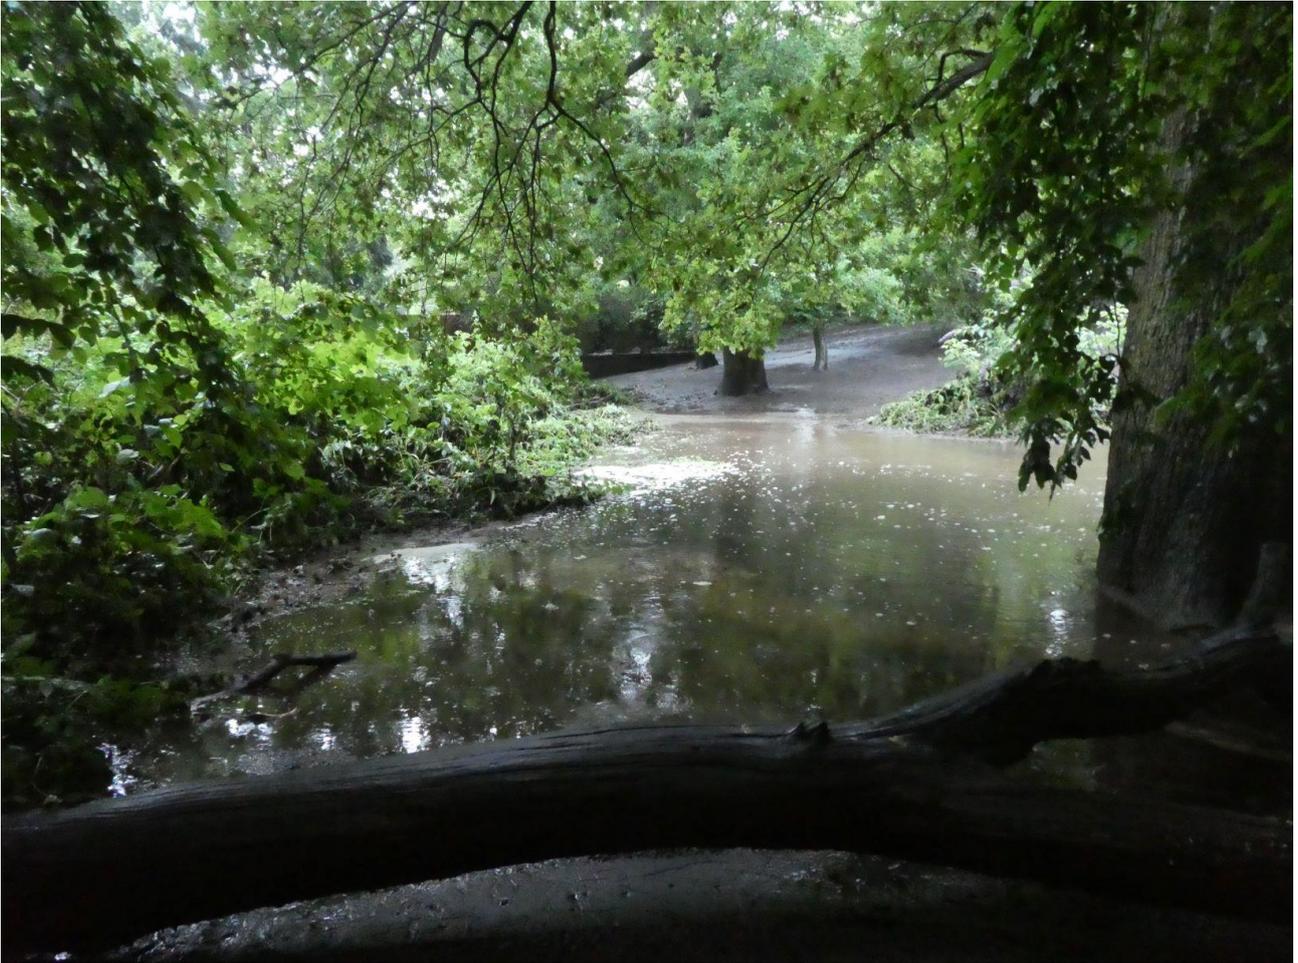
4 8 pm. Another view of the Wood Vale entrance flooded area looking away from the wall.

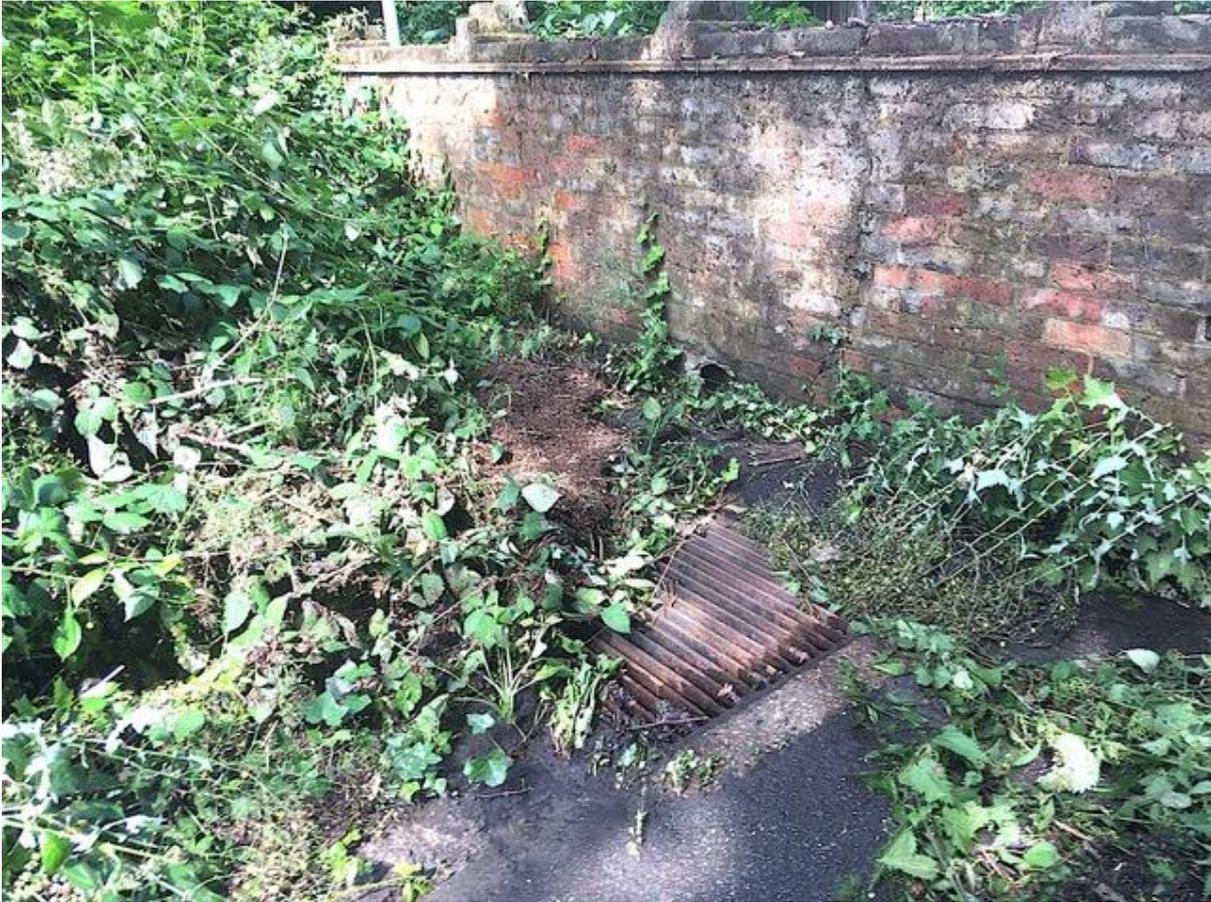
5. Next morning. This shows the Wood Vale entrance wall and inlet grating. The wall is undamaged. Vegetation has been flattened, and has silt on it. There was silt and debris in and around the grating.

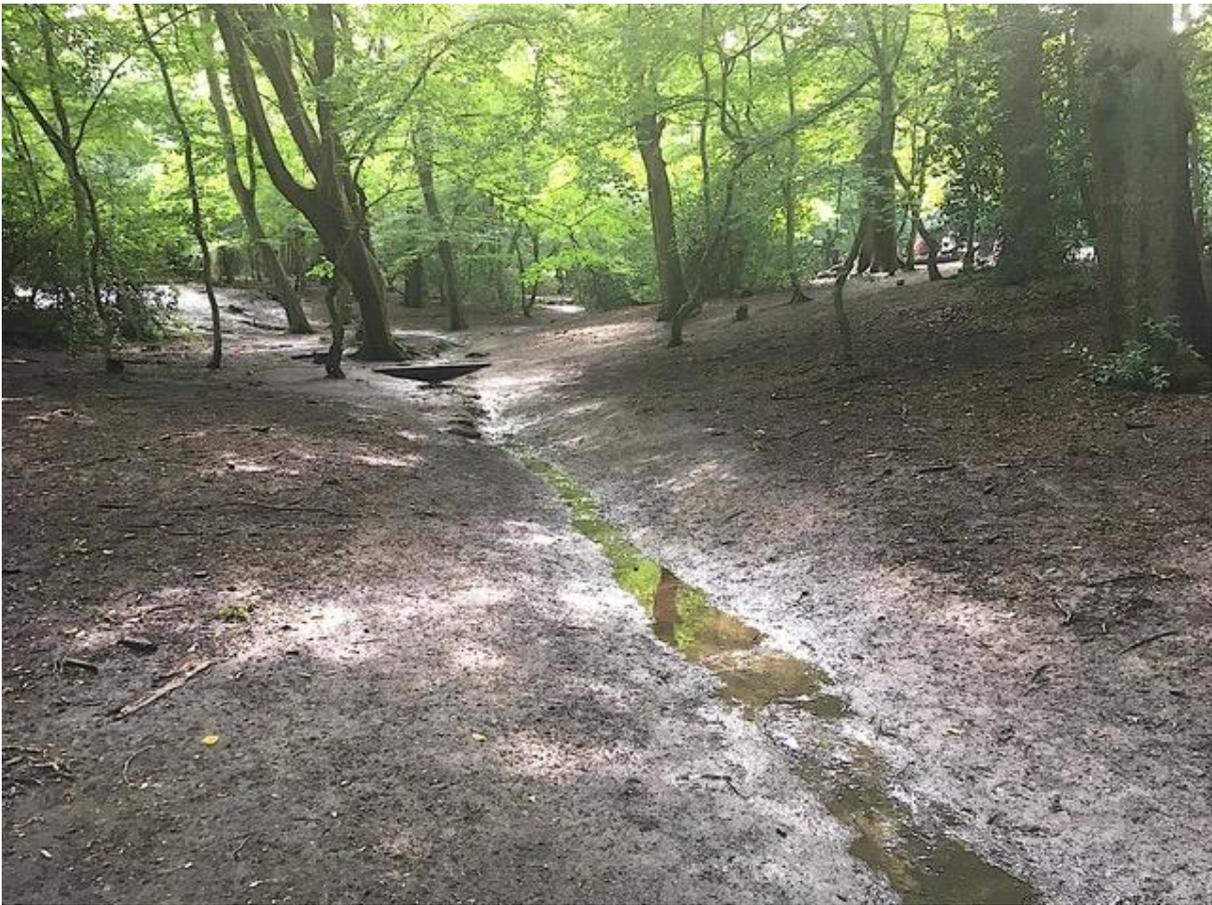
6 Next morning. The Southern branch of Moselle stream between the Frogpool and the Dogpool has little flow. As well as widespread flooding the exposure of the underlying clay can be seen.

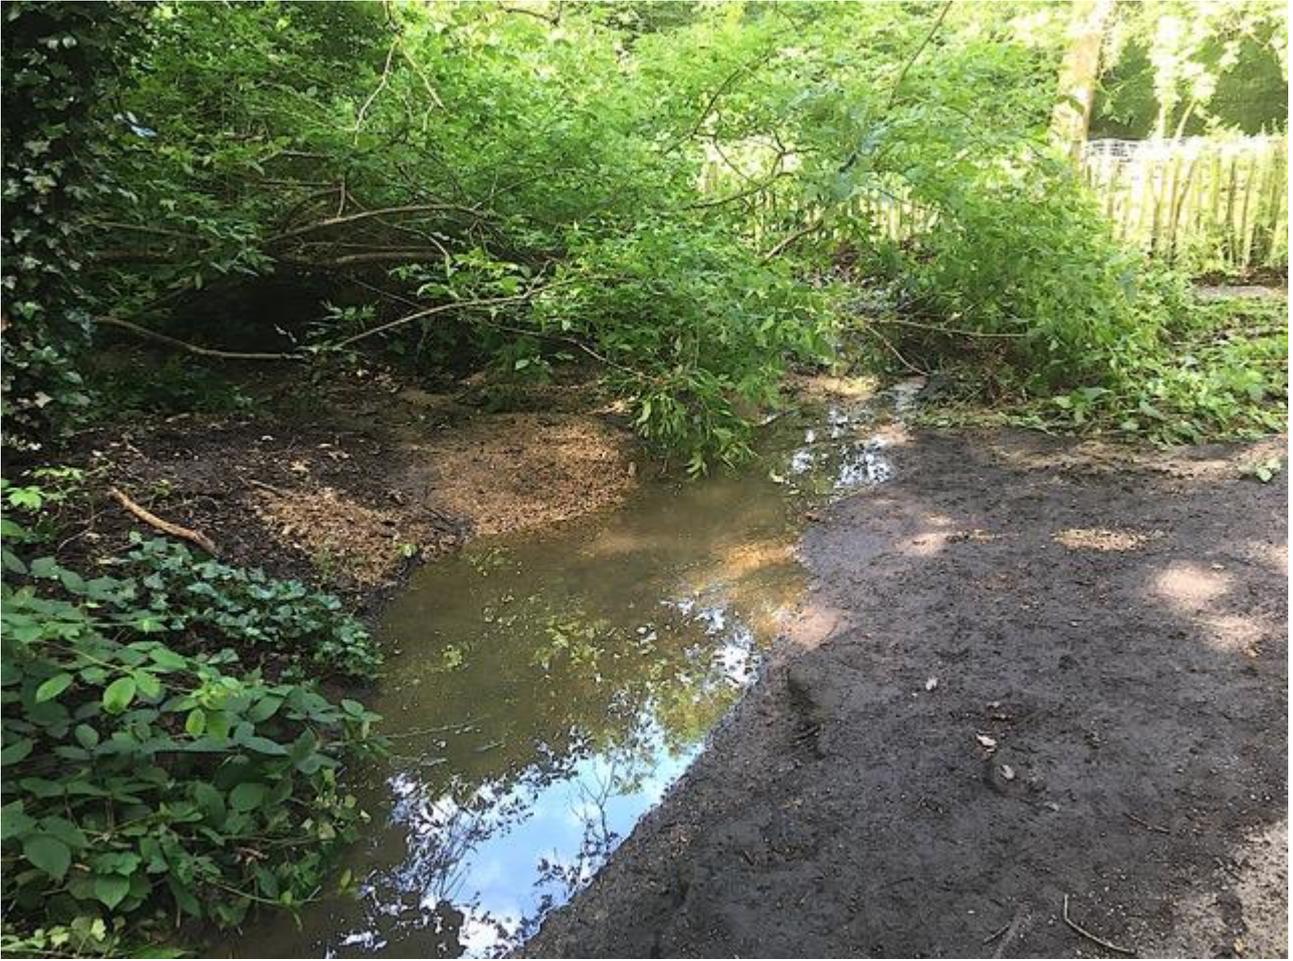
The gully leading into the Frogpool was blocked. This has always been a problem, and it is likely that the flow was restricted before the event. The storm water runoff diverted onto the path to the south of the frog pond with sufficient force to carry a large section of asphalt paving into the gully below the Frogpool.

7. Next morning. The grating forming the inlet of the stream into the Frogpool was blocked had completely disappeared under piles of soil and aggregate.

All of the pipe inlets along the streams were blocked, many before the event. They should be unblocked and regular maintenance carried out.

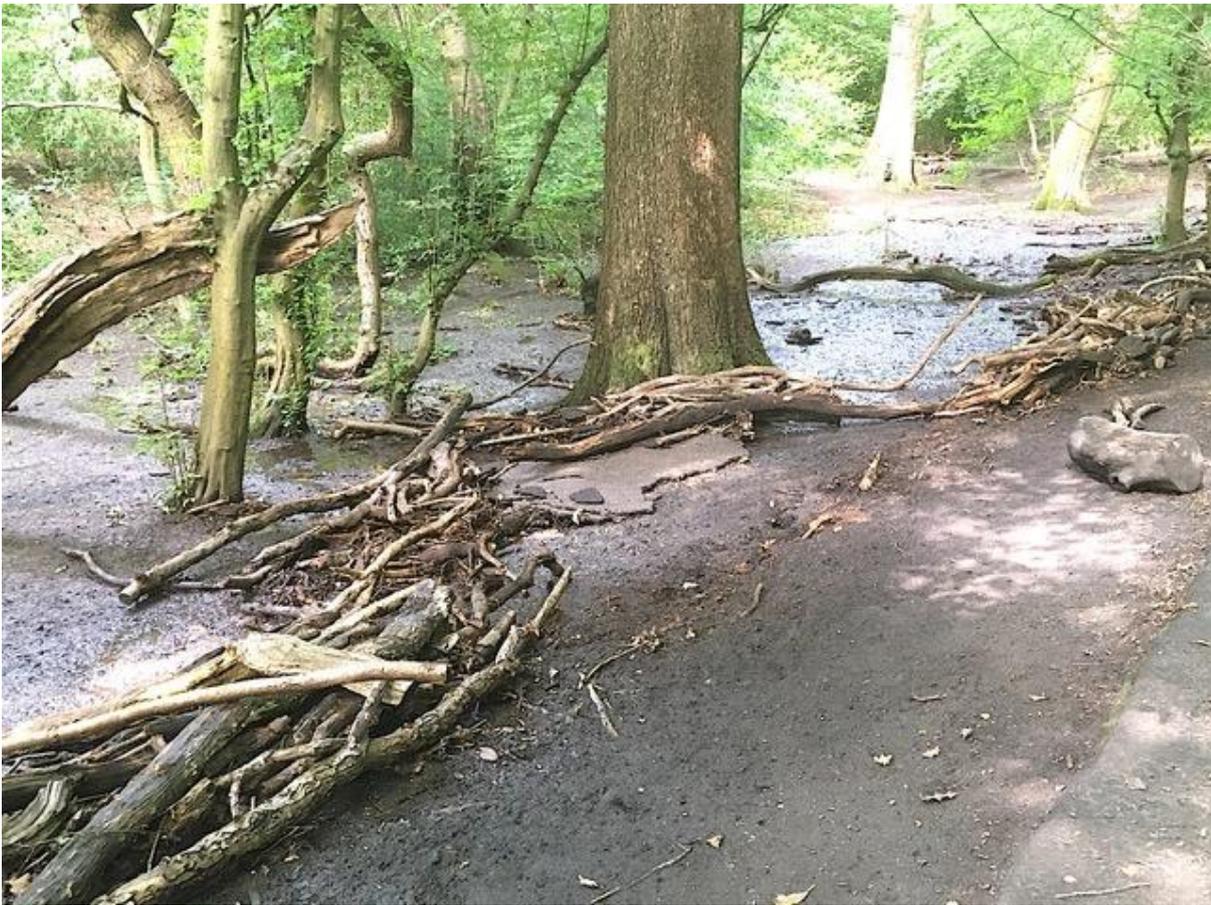
8. Next morning. The stream below the Frogpool towards the Dogpool was the scene of devastation. The area had been flooded with fast-flowing water that removed topsoil and is expected to have destroyed many plants. The protective deadhedge was partially swept away. By the tree a large piece of asphalt can see – taken off the path and moved.

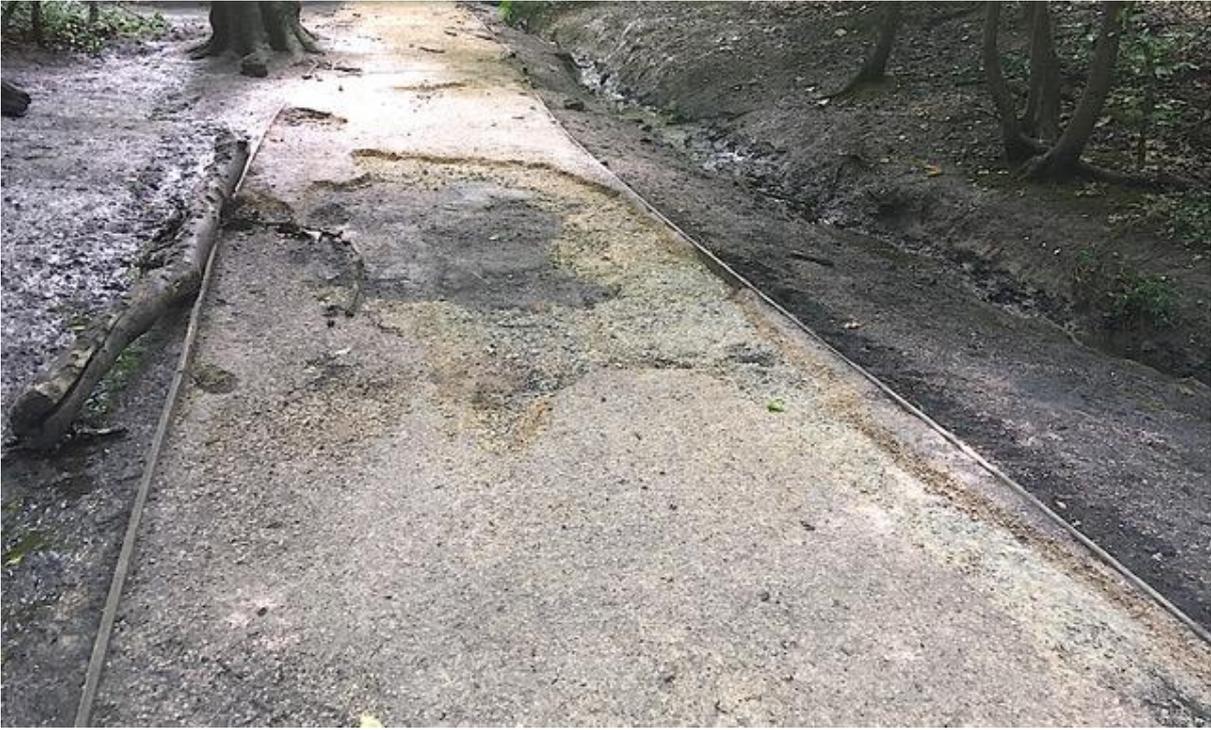
Most of the path network has an asphalt surface -although often in poor condition. The good sections suffered no damage, but in places poor condition asphalt was damaged. However, in recent years a number of paths have been repaired using a graded aggregate surface. Normally this is reasonably self-binding, but with high water flows it can be washed away. Several sections of path were damaged on this occasion, some seriously. In addition the swept away aggregate either is left on the adjacent soil surface – undesirable in a nature reserve – or enters the streams. Here it fills and blocks the streams causing local flooding, or is swept along until it reaches an inlet to the Frogpool, pipes under paths or the main Wood Vale outlet.

9 Next morning. The aggregate surface of the path above the Frogpool had been washed away into the stream and its gullies.
